# HONDA E N G I N E S

OVERHEAD-VALVE ENGINE #38

## ENGINE DISTRIBUTORS SERVICE BULLETIN

### GCV160AS1M • GCV160AS3H APPLIED TO TROY-BILT LAWN MOWERS NO START OR HARD STARTING & SPARK PLUG FOULING

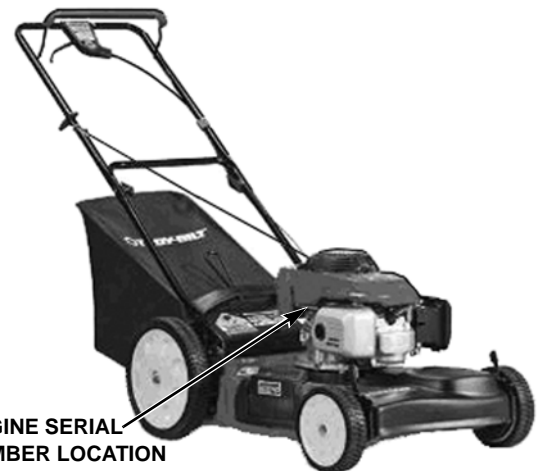
The engine won't start or is difficult to start due to a carbon-fouled spark plug. The problem occurs on ACS (Automatic Choke System) GCV160 engines on certain **Troy-Bilt** lawn mower models. ARCS (Auto Return Choke System) engines are not affected.

The fouling is most likely to occur when the engine is started and the choke butterfly takes too long to open, or the shaft binds in the carburetor, resulting in a fouled spark plug.

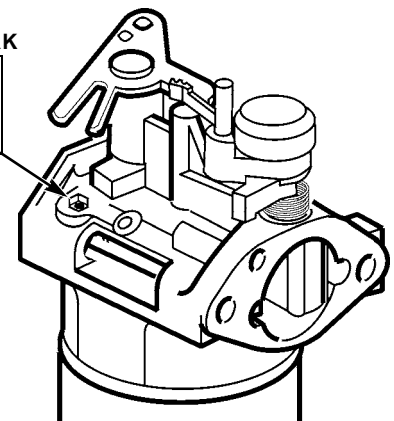
#### BLUE PAINT MARK

Replace the carburetor with a new-style carburetor. New carburetors can be identified by a blue paint mark on the carburetor body as shown.

Blue paint mark is located in the hexagonal hole in this area only.

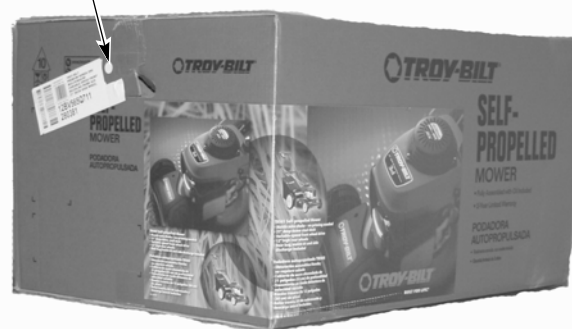
WHITE STICKER DOT

**Units in warehouse inventory:** All affected units that have been repaired at the warehouse can be identified by:

- A white sticker dot on the end of the Troy-Bilt box as shown.
- A white sticker dot on the Troy-Bilt serial number label as shown.
- A blue paint mark located in the hexagonal hole of the carburetor (see page 1).

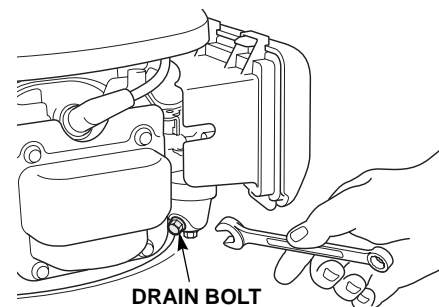
1. Turn the fuel valve to the OFF position.
2. Before removal, completely drain the carburetor into an approved container.
3. Disconnect the spark plug cap from the spark plug.

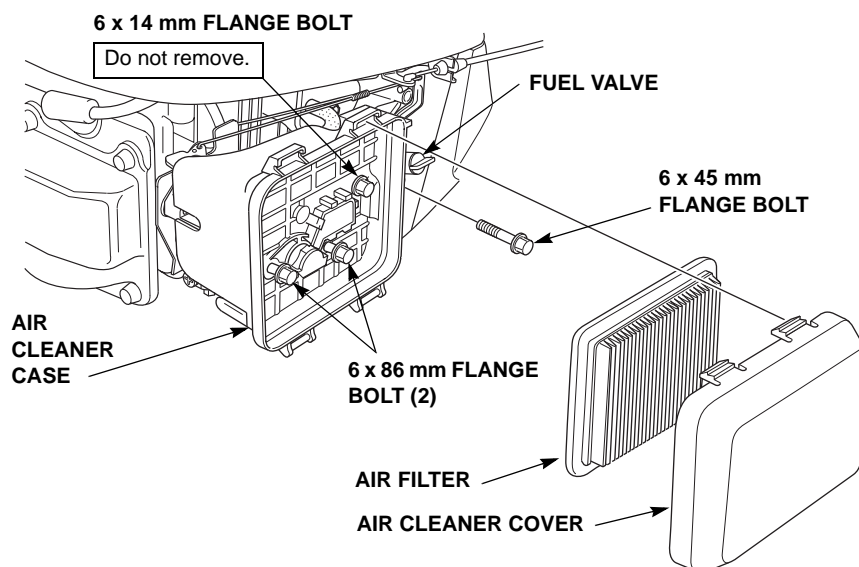
4. Remove the air cleaner cover and air filter.
5. Remove the 6 x 45 mm flange bolt.
6. Completely loosen the two 6 x 86 mm flange bolts securing the air cleaner case, but do not remove them.  
Do not remove the 6 x 14 mm flange bolt.

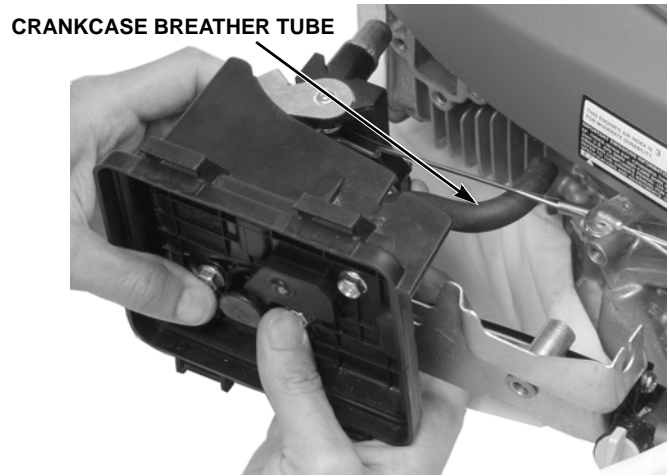
7. Disconnect the crankcase breather tube from the engine while holding the bolts in place, then pull the air cleaner case, carburetor, air guide, and auto-choke assembly as a unit away from the engine. Rotate the assembly and lay it on the lawn mower cutter deck.

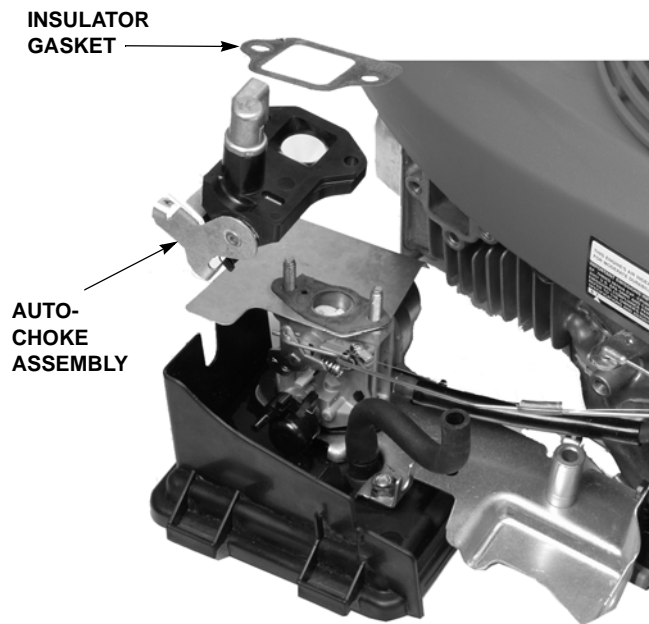
8. Remove the auto-choke assembly and the insulator gasket from the two 6 x 86 mm flange bolts.

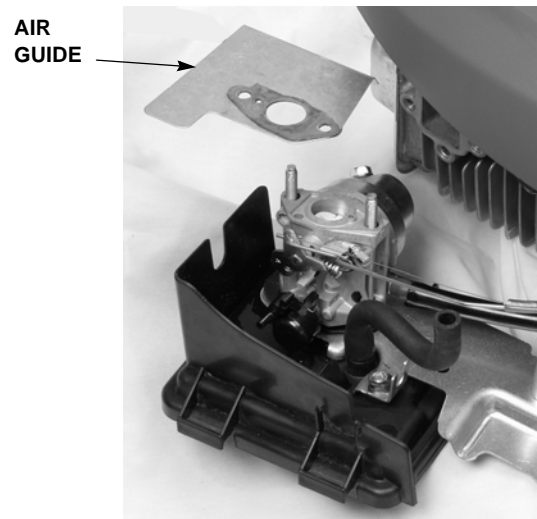
9. Remove the air guide from the two 6 x 86 mm flange bolts.

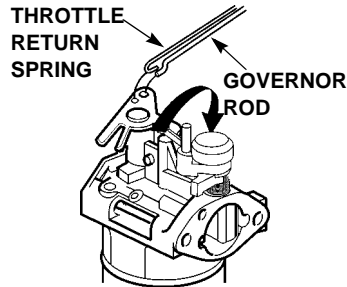
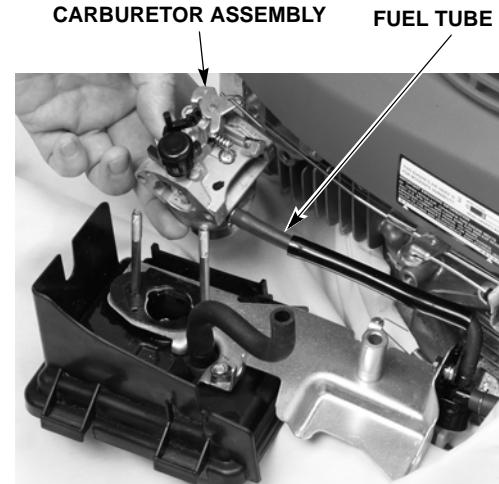
10. Remove the carburetor from the two 6 x 86 mm flange bolts.
11. Remove the fuel tube from the carburetor.
12. Remove the throttle return spring, and then rotate the carburetor in the direction shown and remove the governor rod from the carburetor.

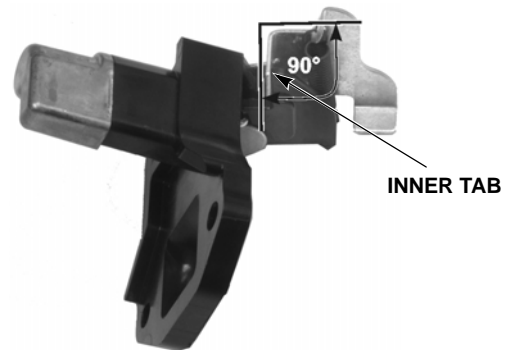
13. Inspect the inner tab on the auto-choke assembly and confirm the inner tab angle is no more than 90 degrees. The auto-choke mechanism must be cold to perform the inspection. If the tab angle is greater than 90 degrees, bend the tab until it is 90 degrees.

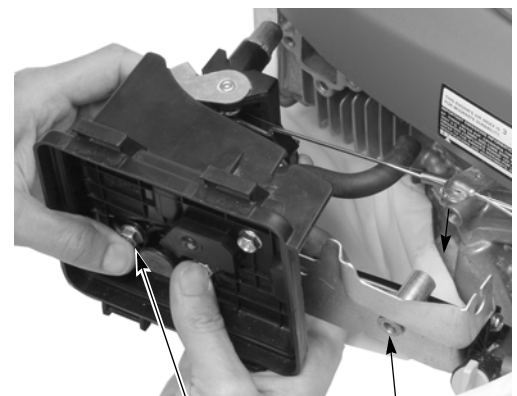
14. Before reassembling the components back onto the two 6 x 86 mm flange bolts, inspect all of the gaskets. Replace any gasket that is not reusable.
15. Install the throttle return spring, governor rod, and fuel tube to the new carburetor.
16. Install the new carburetor onto the two 6 x 86 mm flange bolts.
17. Install the air guide onto the two 6 x 86 mm flange bolts.
18. Install the auto-choke assembly and the insulator gasket onto the two 6 x 86 mm flange bolts.
19. Pick up the assembled air cleaner case, carburetor, air guide, and auto-choke assembly as a unit. Install it to the cylinder block by aligning the two 6 x 86 mm flange bolts with their mounting holes.
20. Loosely install the two 6 x 86 mm flange bolts.
21. Loosely install the 6 x 45 mm flange bolt.

6 x 86 mm FLANGE BOLT (2)

6 x 45 mm  
FLANGE BOLT  
(shown removed)

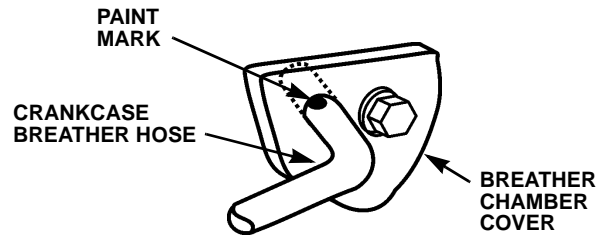
22. Install the crankcase breather hose with the painted mark even with the breather chamber cover.

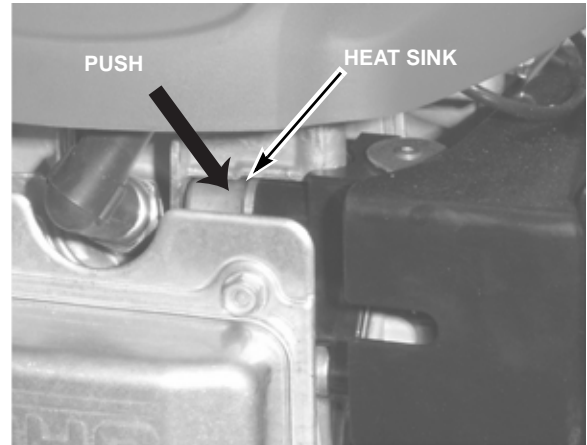
23. Push the aluminum heat sink down toward the rear of the engine (parallel to the spark plug). Continue to apply pressure to the heat sink and retighten the 6 x 86 mm flange bolts to the specified torque. This will ensure the heat sink is properly contacting the cylinder head.

**TORQUE: 10.0 N•m (7.0 ft-lb)**

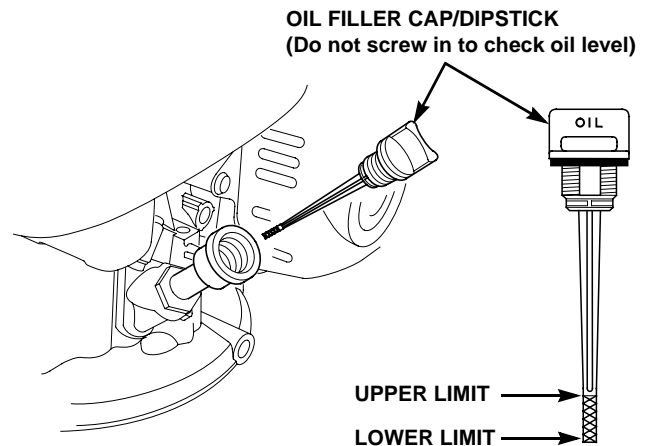
24. Tighten the 6 x 45 mm flange bolt.  
 25. Install the air filter and air cleaner cover.  
 Inspect the air filter element and replace or clean as necessary.  
 26. Turn the fuel valve ON and check for fuel leaks.  
 27. Check the engine oil level and confirm it's not overfilled. The level must not extend beyond the upper limit mark.

Excess engine oil can also result in spark plug fouling. Drain excess oil if necessary.

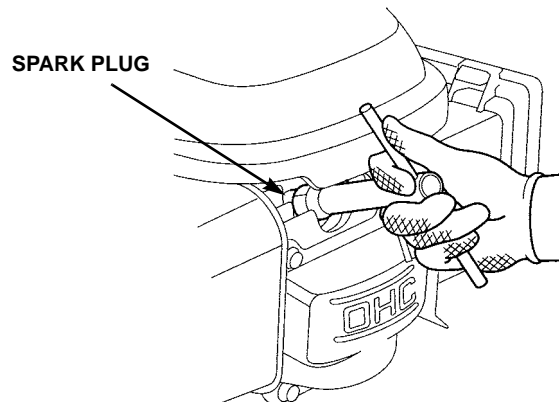
28. Remove and replace the spark plug with the higher heat range BPR5ES spark plug.  
 29. Reinstall the spark plug cap.  
 30. Start and test the operation of the engine.
